**FLIR Technology – Precise
& Absolute Validation Of
The Insulation Process**

Rovanco® Piping Systems

Our Process for Foam Insulating Success

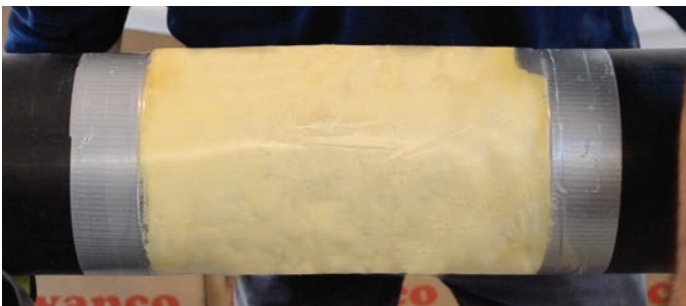
Note: Picture above depicts pipe with open section to show no voids after foam insulation is injected.

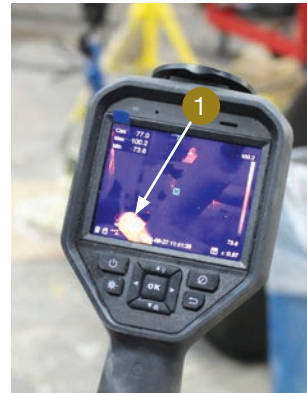
1 Foam being injected – starts to expand from bottom of pipe.

- Foam insulation expands producing heat allowing FLIR to monitor flow.
- Expanding foam appears as bright yellow/orange & empty voids as cooler blue/purple color.
- Technology allows Rovanco QC Technician to monitor process & assure total air space is filled.

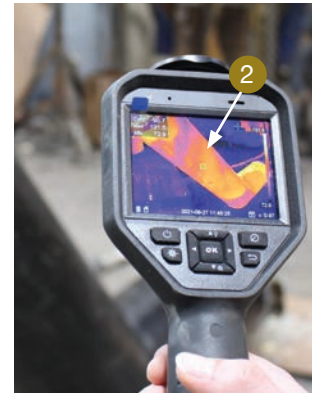
2 Foam expands upward to fill entire air space of piping.

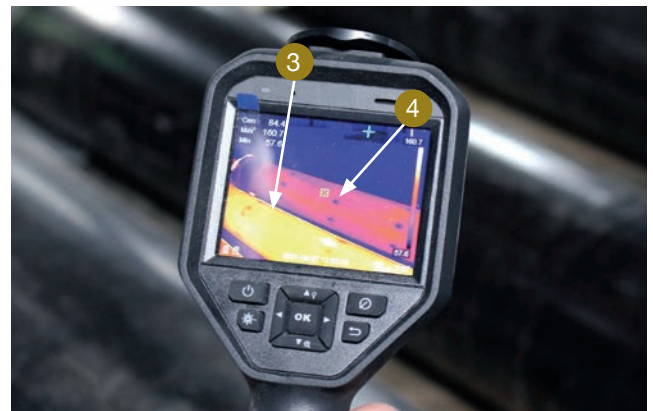
3 Foam expanded and air space totally filled with insulation.

4 Foam continuing to expand, black dots shown are spacers which are hollow to allow continuous insulation.

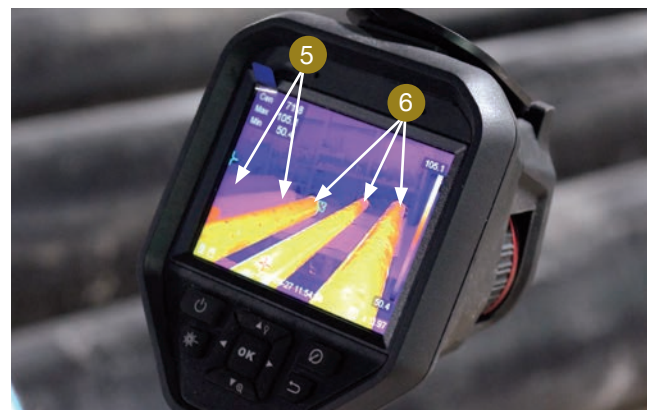
5 Two pipes on the left are awaiting the injecting of the foam.

6 Three pipes on right have expanding foam filling the air space.
